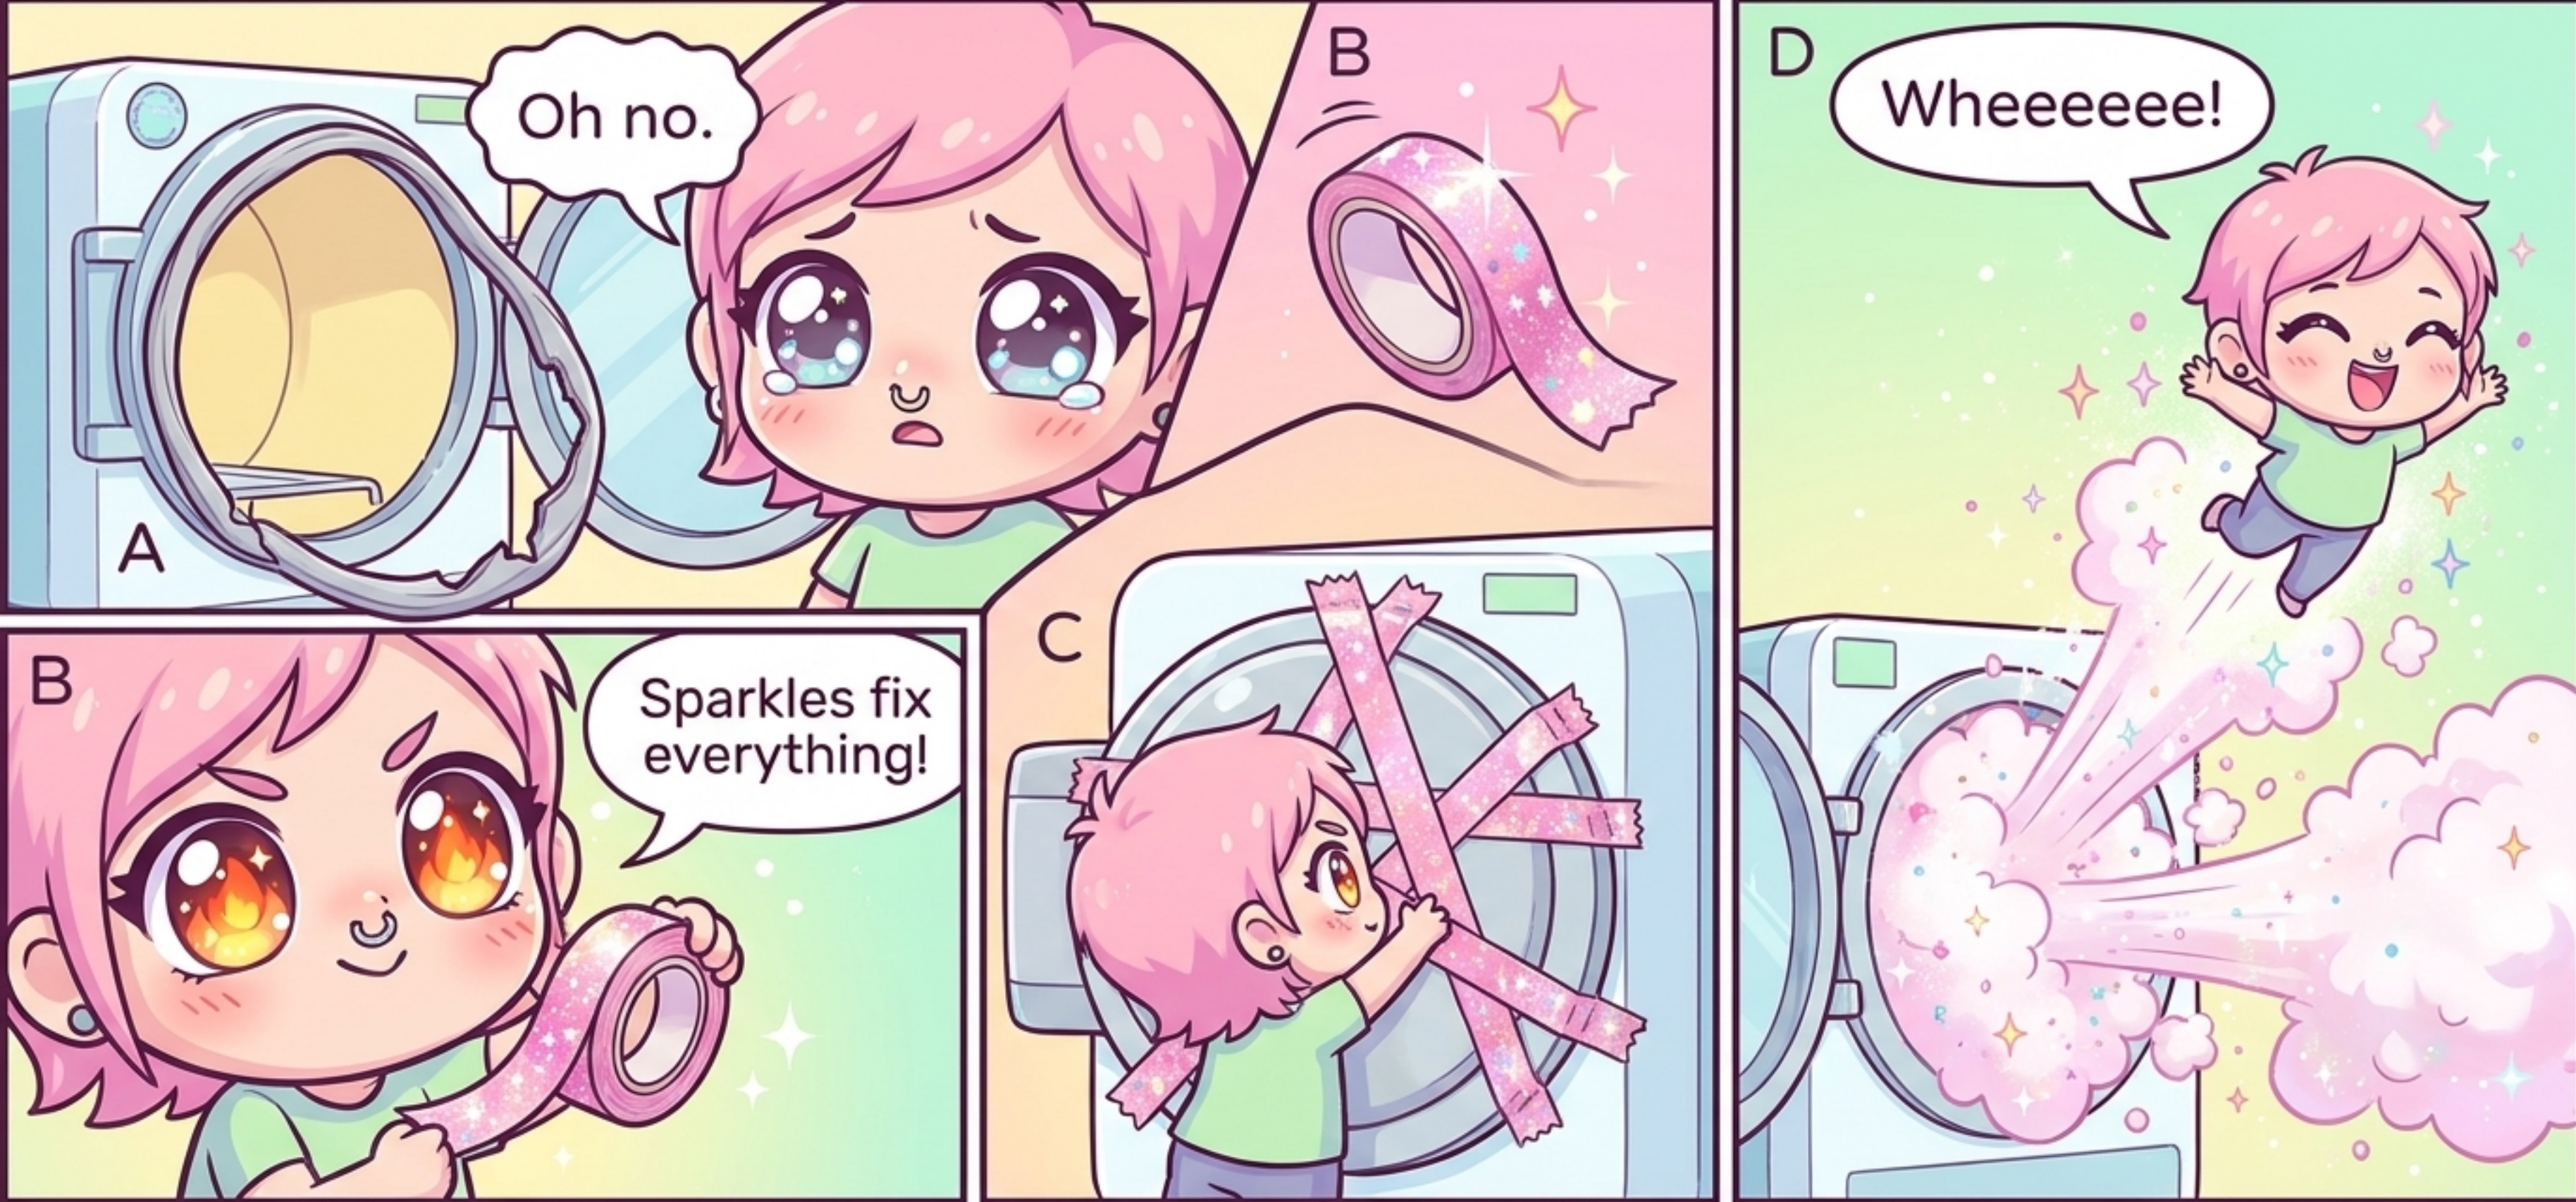
Visible damage or flattening of the silicone door gasket prevents the autoclave from holding pressure.

**Fixing a broken high-pressure steam seal with decorative tape is optimism taken to its illogical extreme.**
