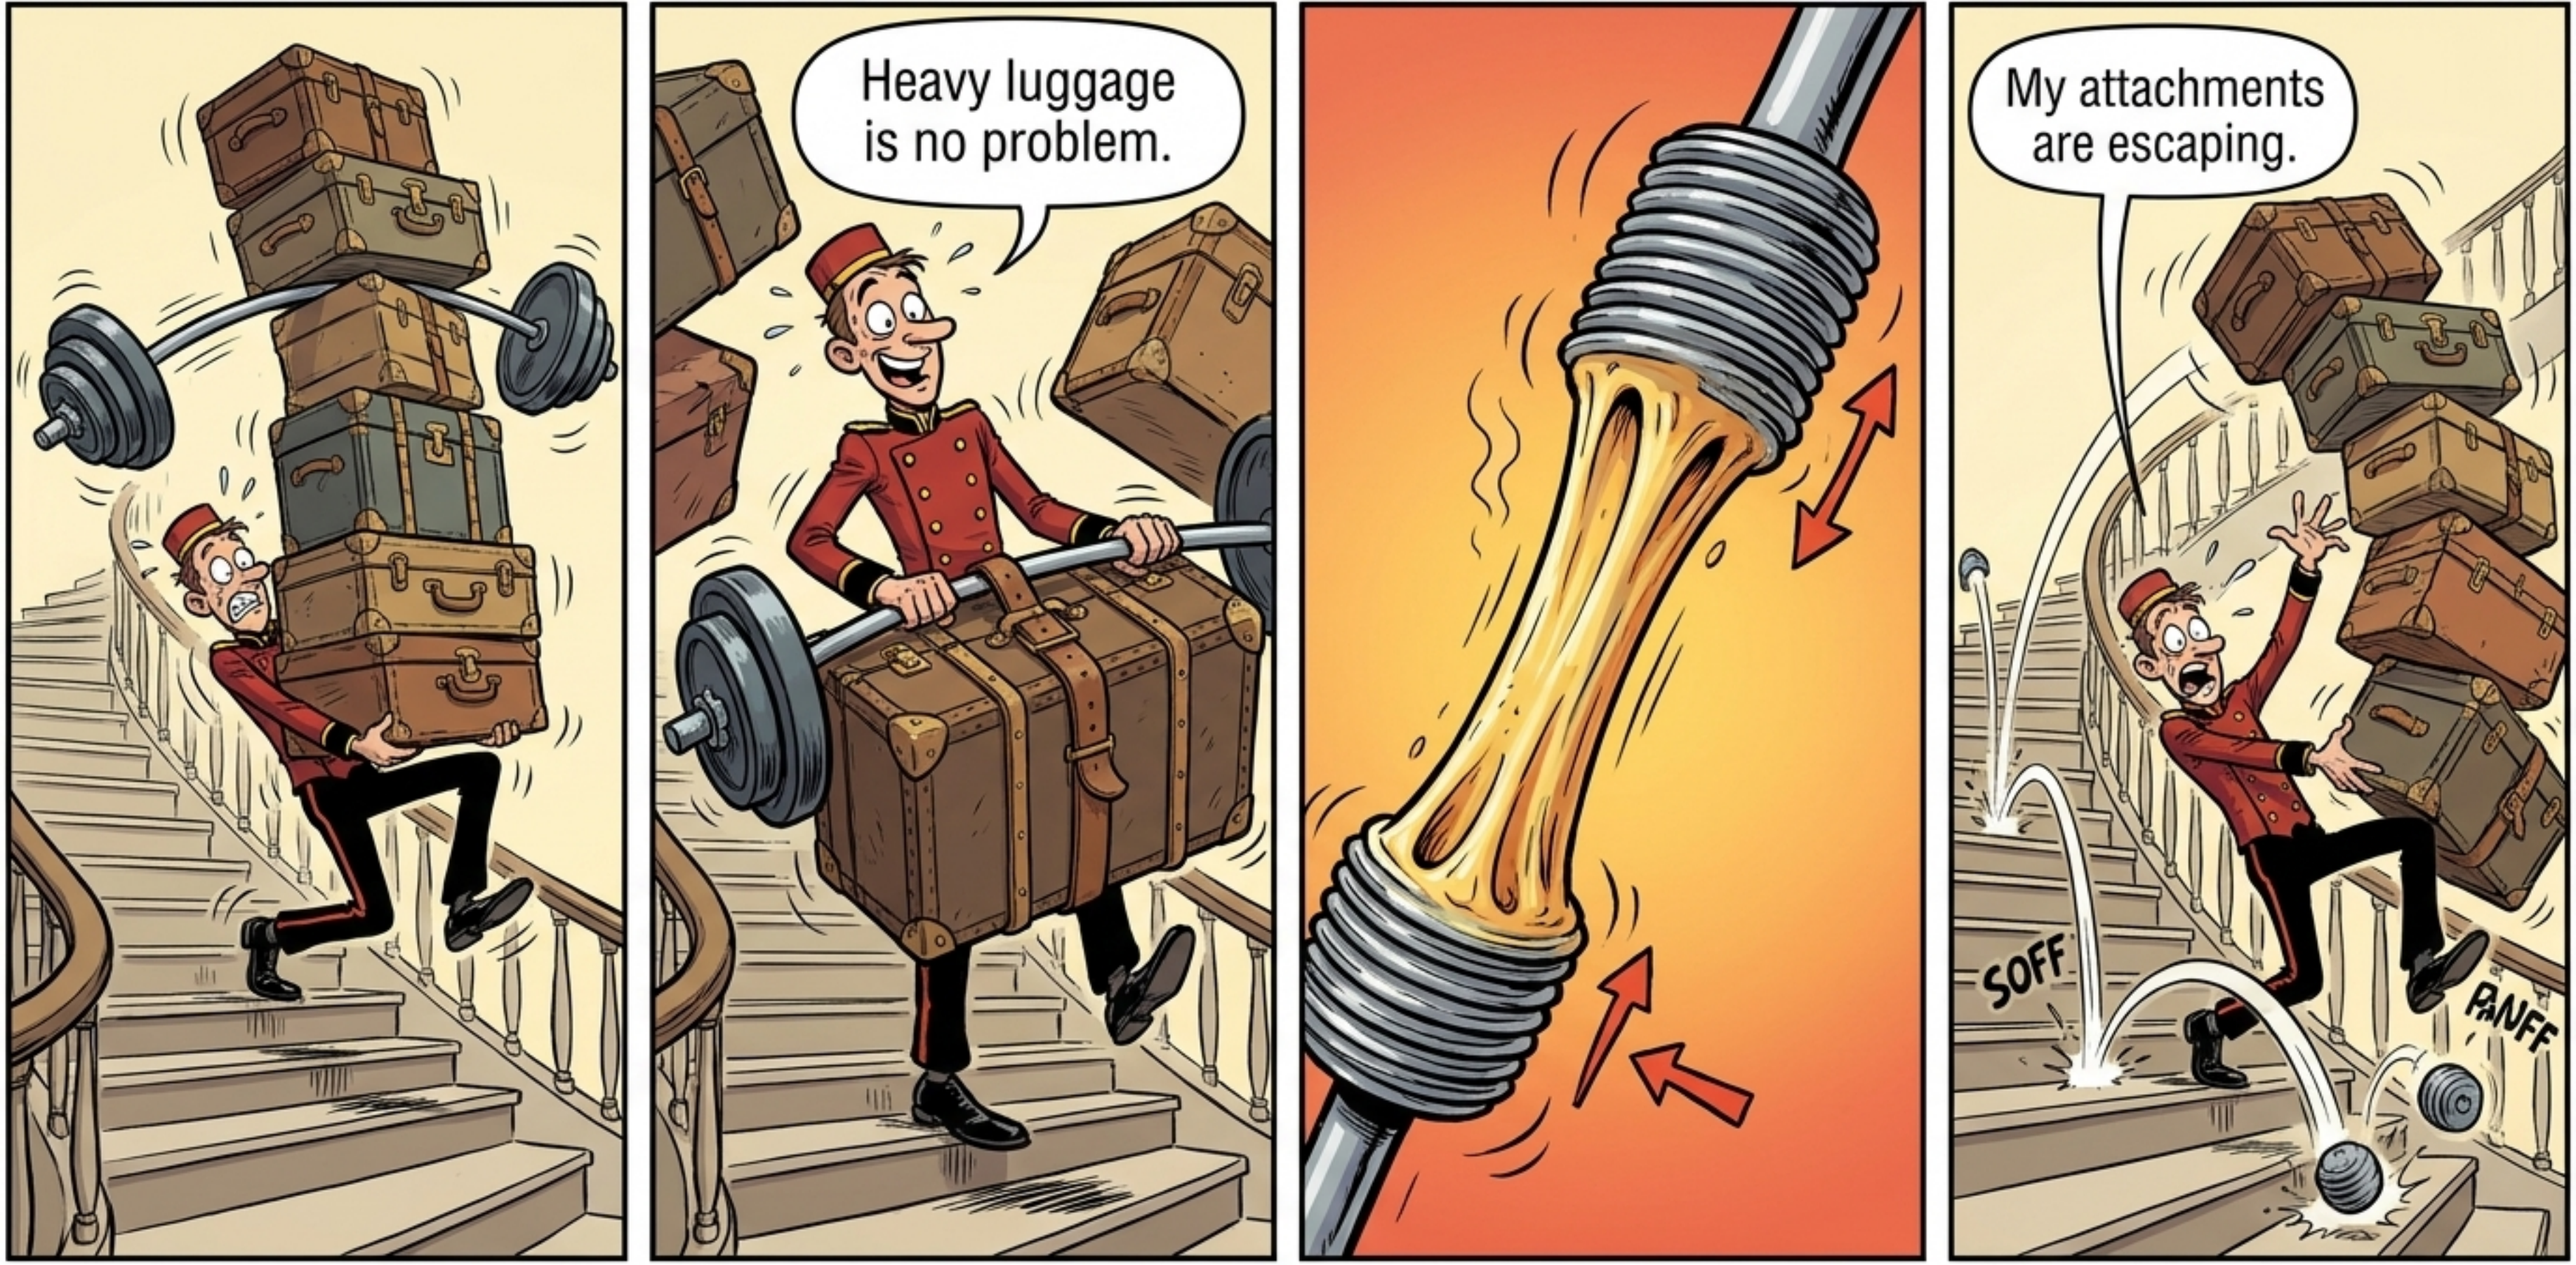
Polytetrafluoroethylene exhibits cold flow under sustained mechanical load allowing threaded connections to loosen.

The sudden loss of structural integrity proved quite distracting during the staircase descent.
