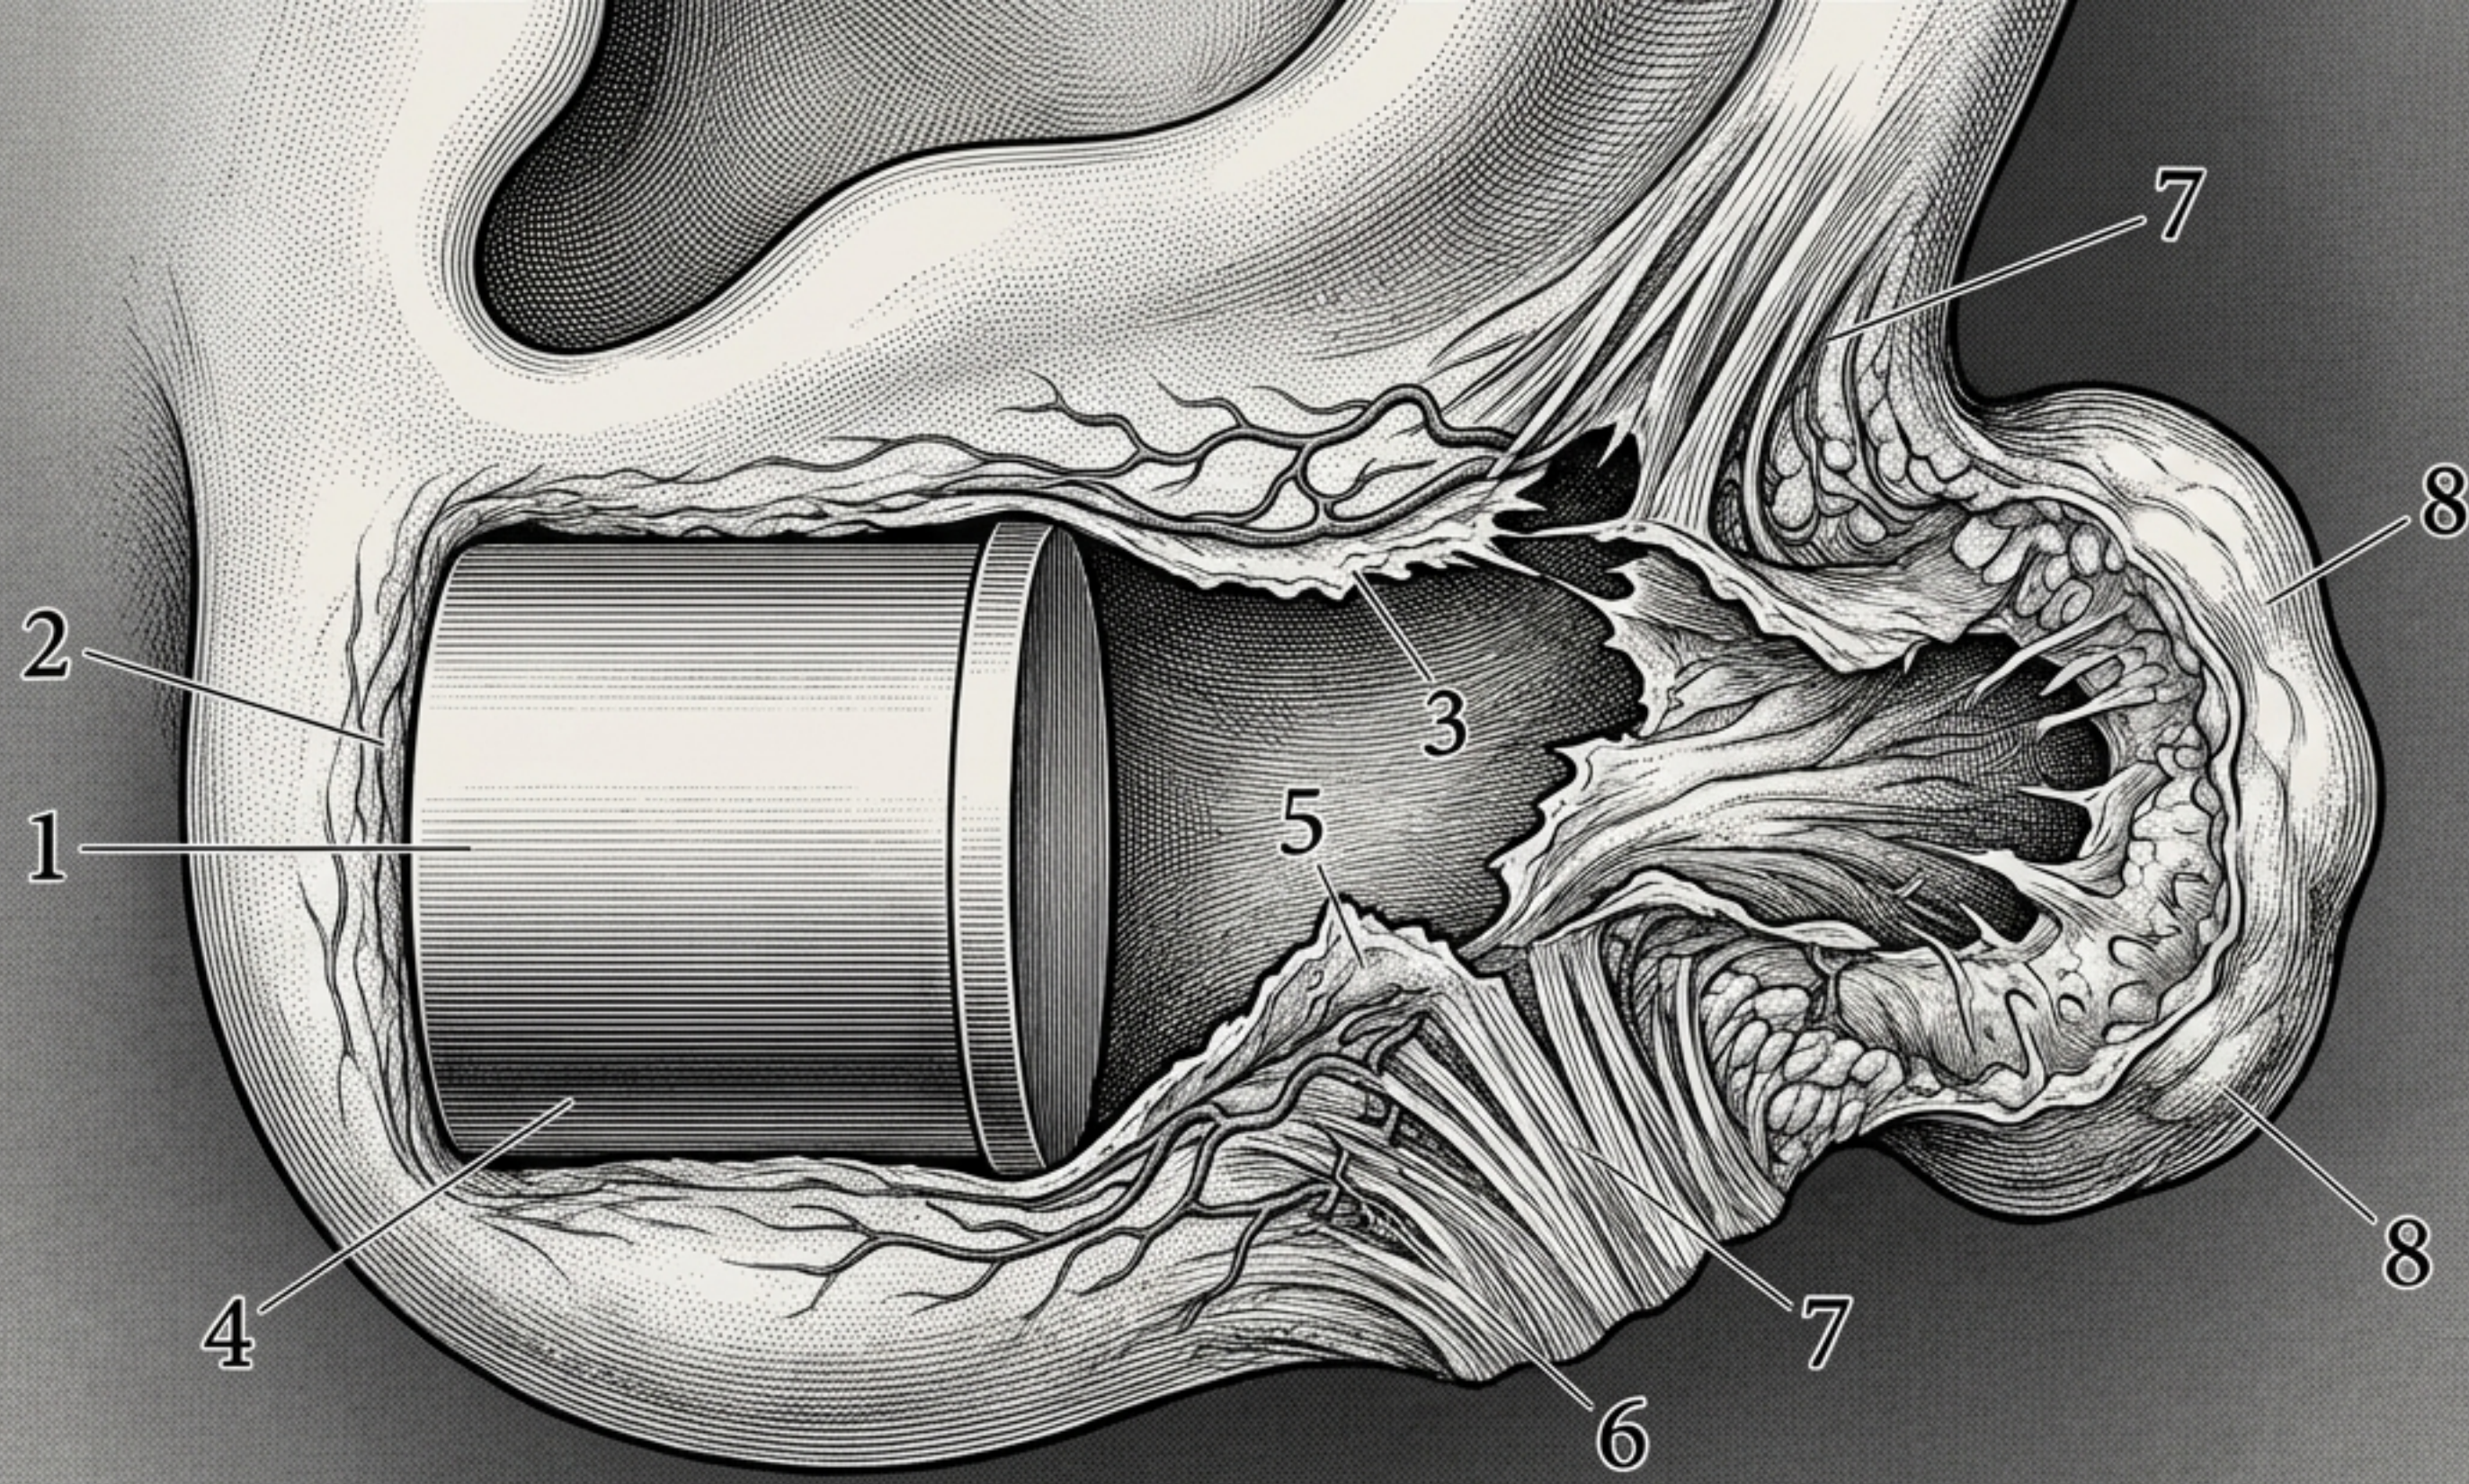
1. 8.0mm plug applies constant load
2. Stretched healed fistula tissue tube
3. Inner lining mechanically extruded backward
5. Torn interface of healing tissue
6. Hypoxic compressed capillary blood bed
7. Radially aligned collagen scar tissue
8. Swollen ring of excess tissue

1. Asymmetric pressure from from insertion taper
4. Hsymmetric pressure to hiniio
5. Torn interface of healing tiss
7. Radially align collagen scar tissue
8. Swollen ring of excess tissue

A blowout is a structural mechanical injury to the fistula wall, not a topical infection.  
**RAPID FORCED DILATION TEARS COLLAGEN.**
