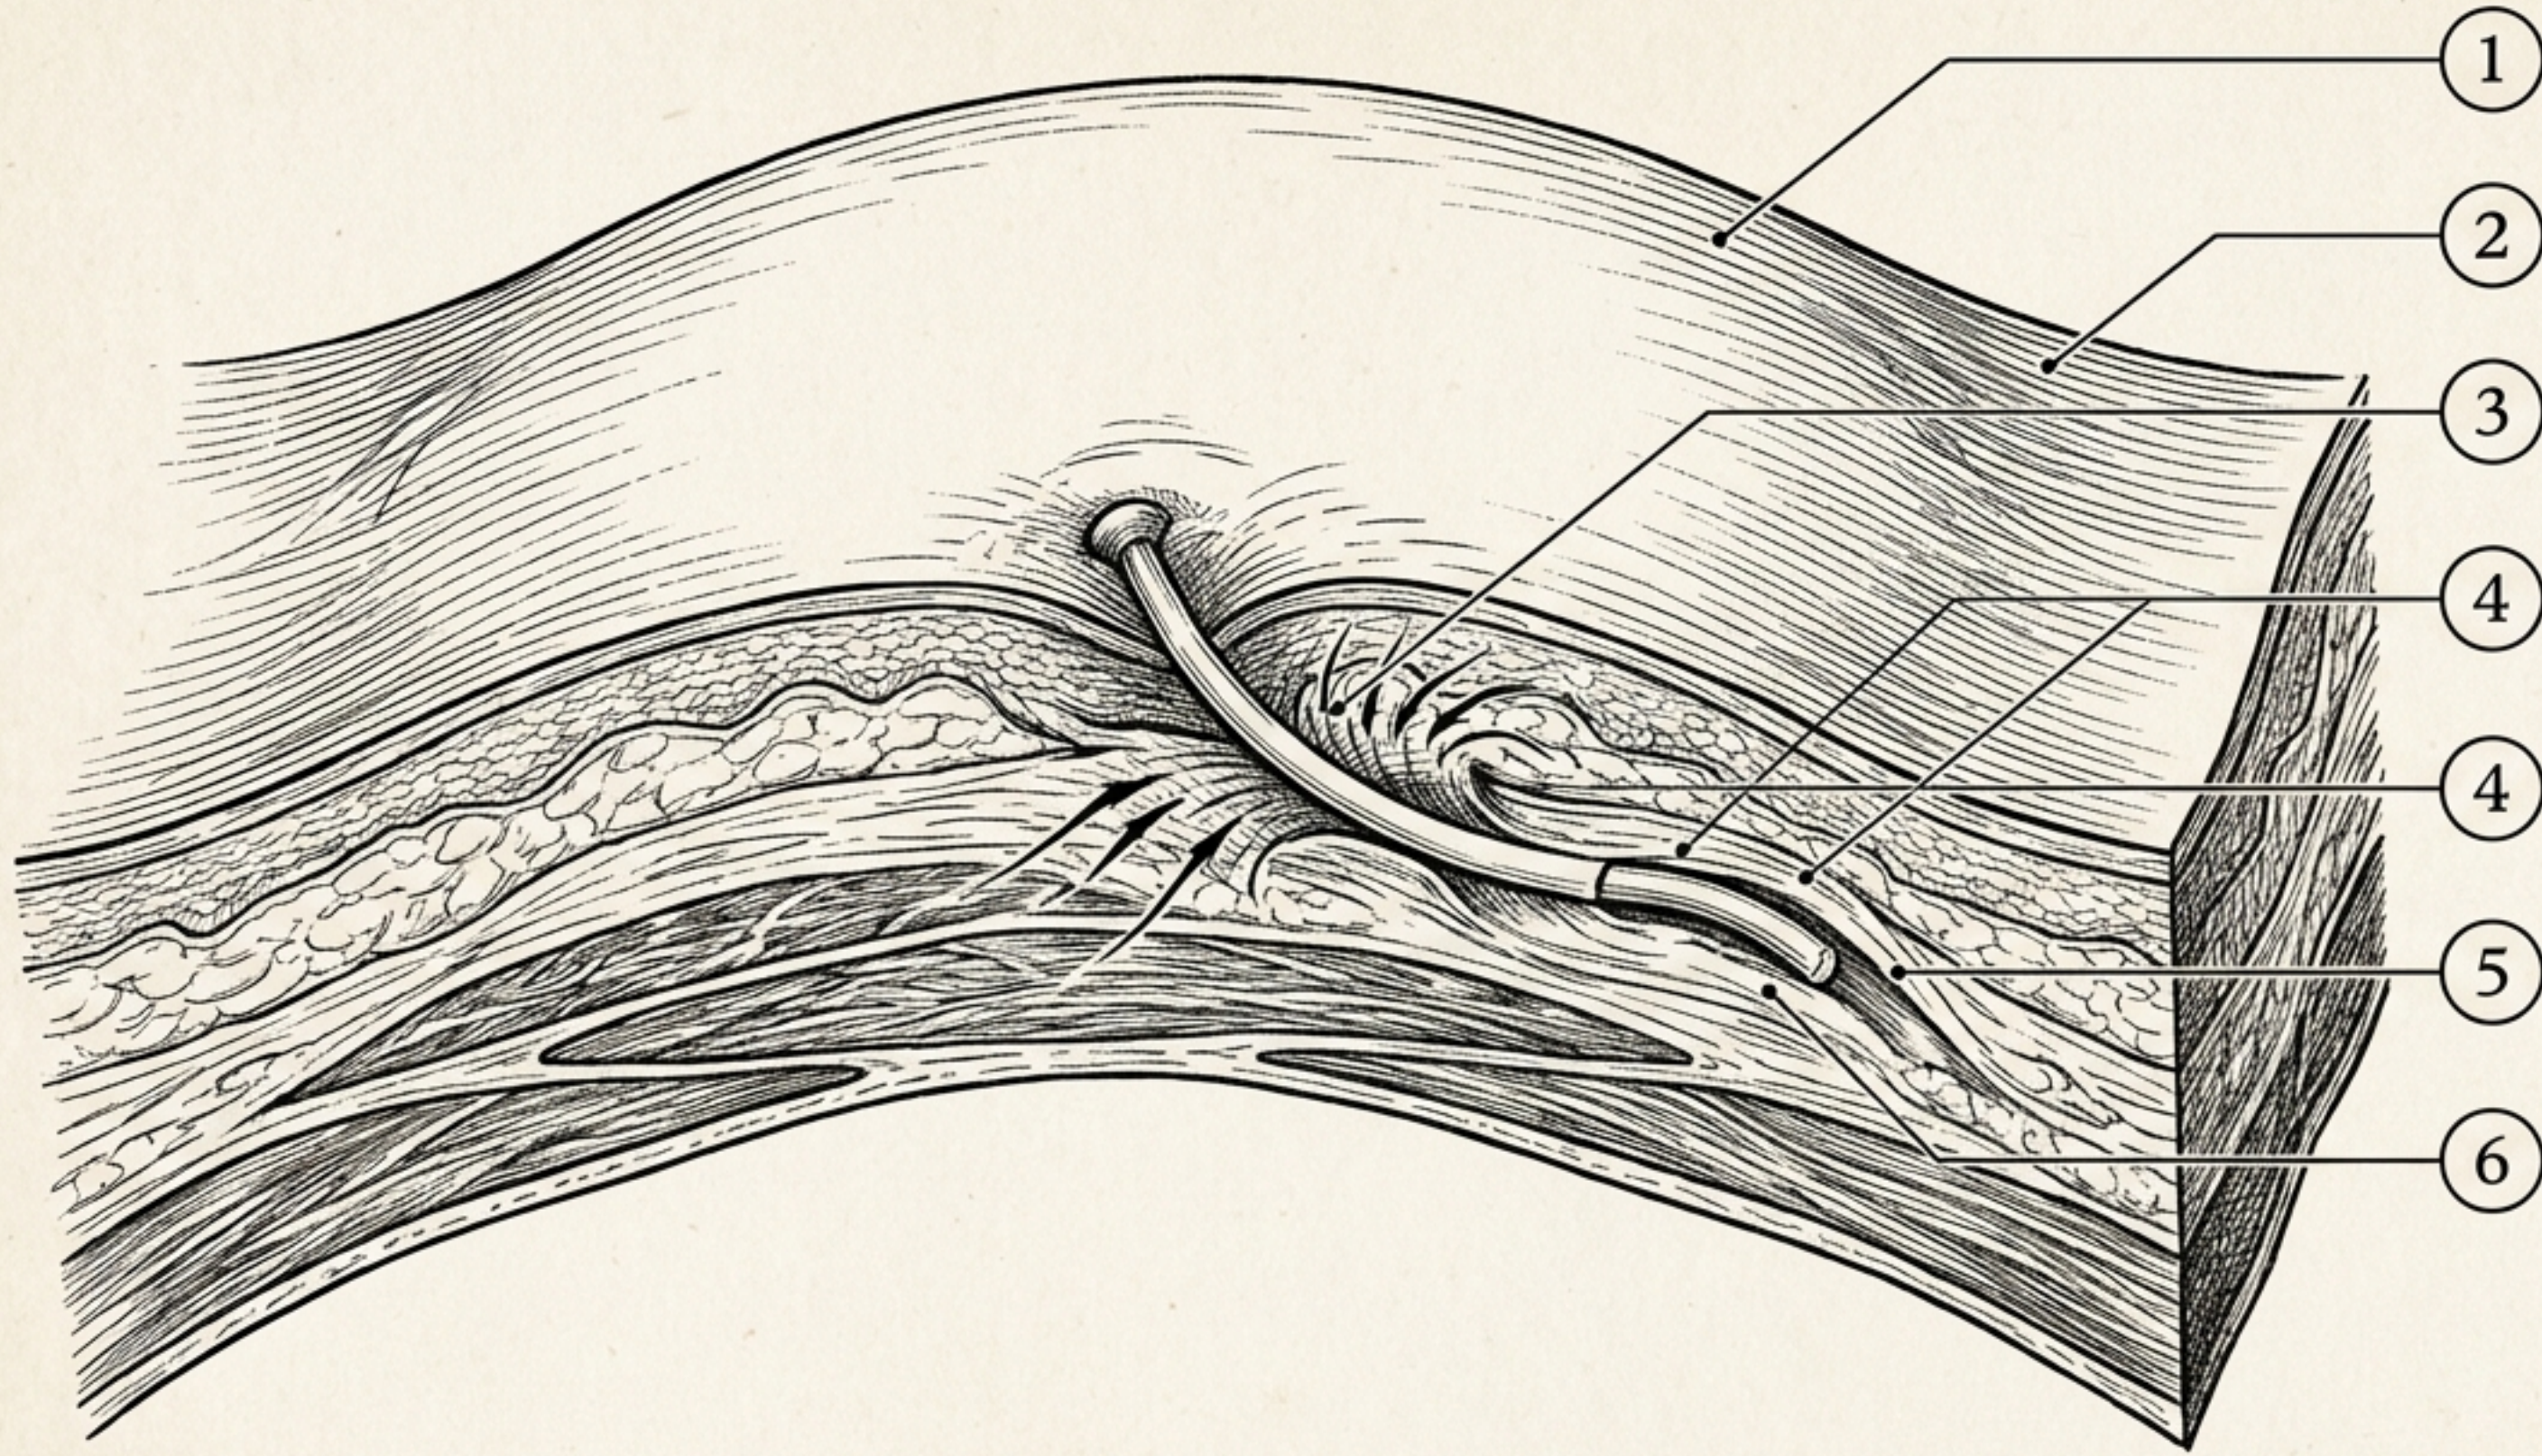
1. Expanding abdominal wall
2. Stretched skin surface
3. Changed piercing angle
4. Mechanical stress on fistula

1. Expanding abdominal wall
2. Stretched skin surface
4. Mechanical stress on fistula
5. Increased migration risk
6. Biocompatible polymer retainer

Expanding tissue places mechanical stress on existing fistulas, increasing the risk of migration and rejection.  
**REPLACE METAL JEWELLERY WITH FLEXIBLE PTFE RETAINERS.**
